# **TUMBARUMBA INTEGRATED WATER CYCLE MANAGEMENT STRATEGY**

## **Evaluation Study**

**TUMBARUMBA SHIRE COUNCIL**

**June 2008**

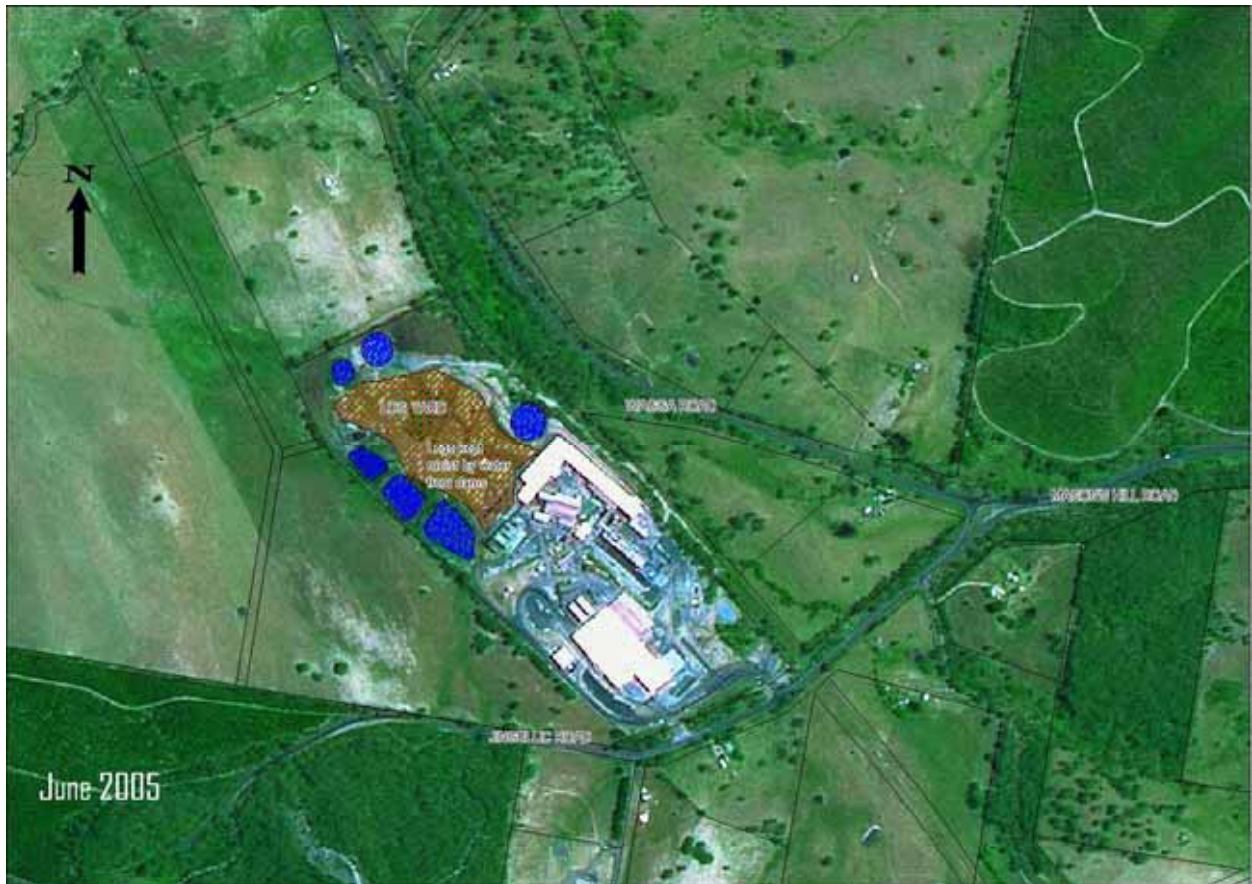
**Figure 2.3: Layout of the Hyne & Son Pty Ltd Timber Mill**

The largest industry in Tumbarumba Shire is the Hyne & Son Pty Ltd Timber Mill on the outskirts of Tumbarumba township (refer Figure 2.3 for layout and Figure 3.1 for location). The mill produces a T2 product that has been treated with an oil blend containing a common insecticide (Permethrin). No copper, chromium or arsenic products are used for treating timber.

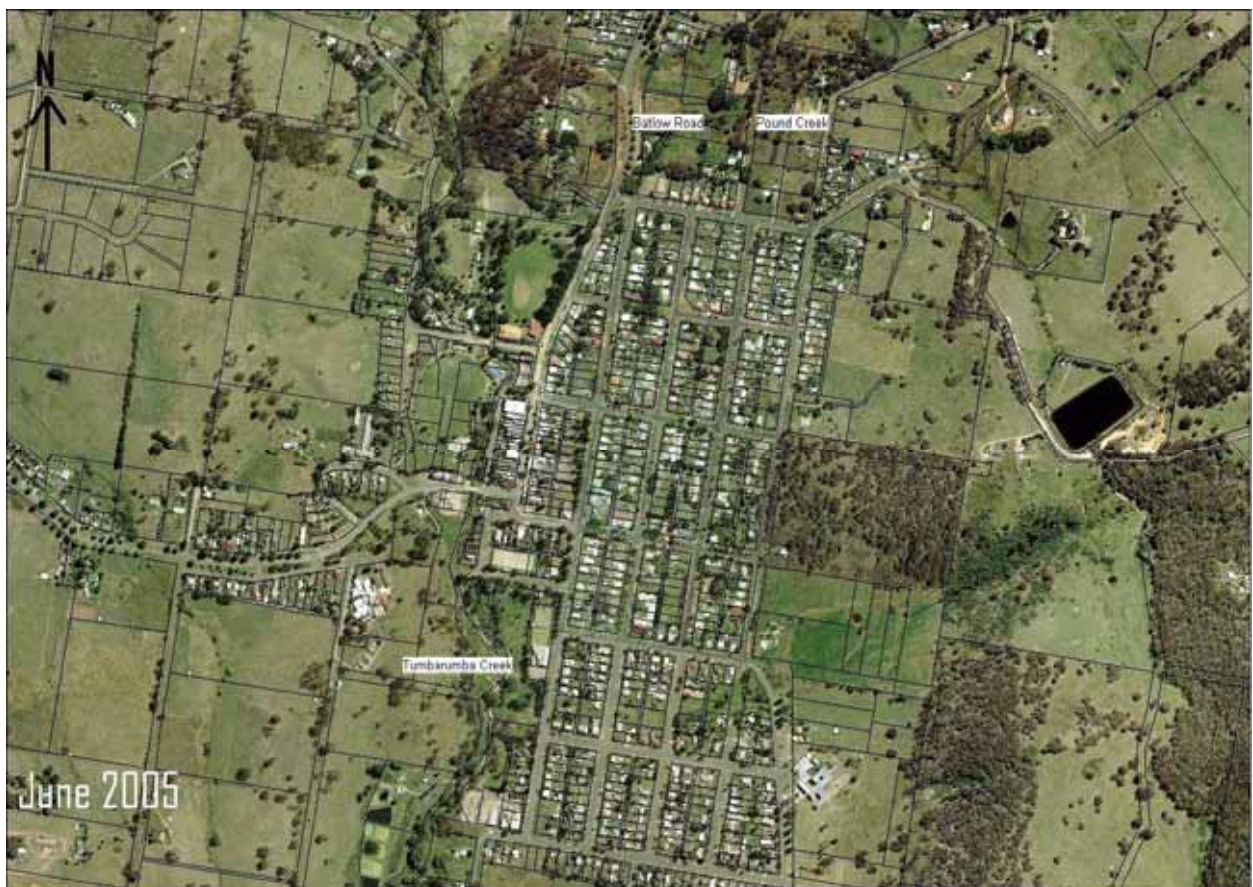
**Figure 2.4: Layout of Tumbarumba Township**

Tumbarumba Creek flows through the township in an approximate north to south direction along land that is predominantly zoned for public recreation with some small areas zoned rural (1A). Tumbarumba Creek is fed by Pound Creek, which flows to the east of Batlow Road. Water is extracted from both of these streams for domestic and rural uses.

Tumbarumba Creek and Pound Creek are classified as uncontrolled streams by the Murray CMA and both are unregulated. Tumbarumba Creek flows to Mannus Creek, which is classified as a controlled stream with an altered flow pattern.

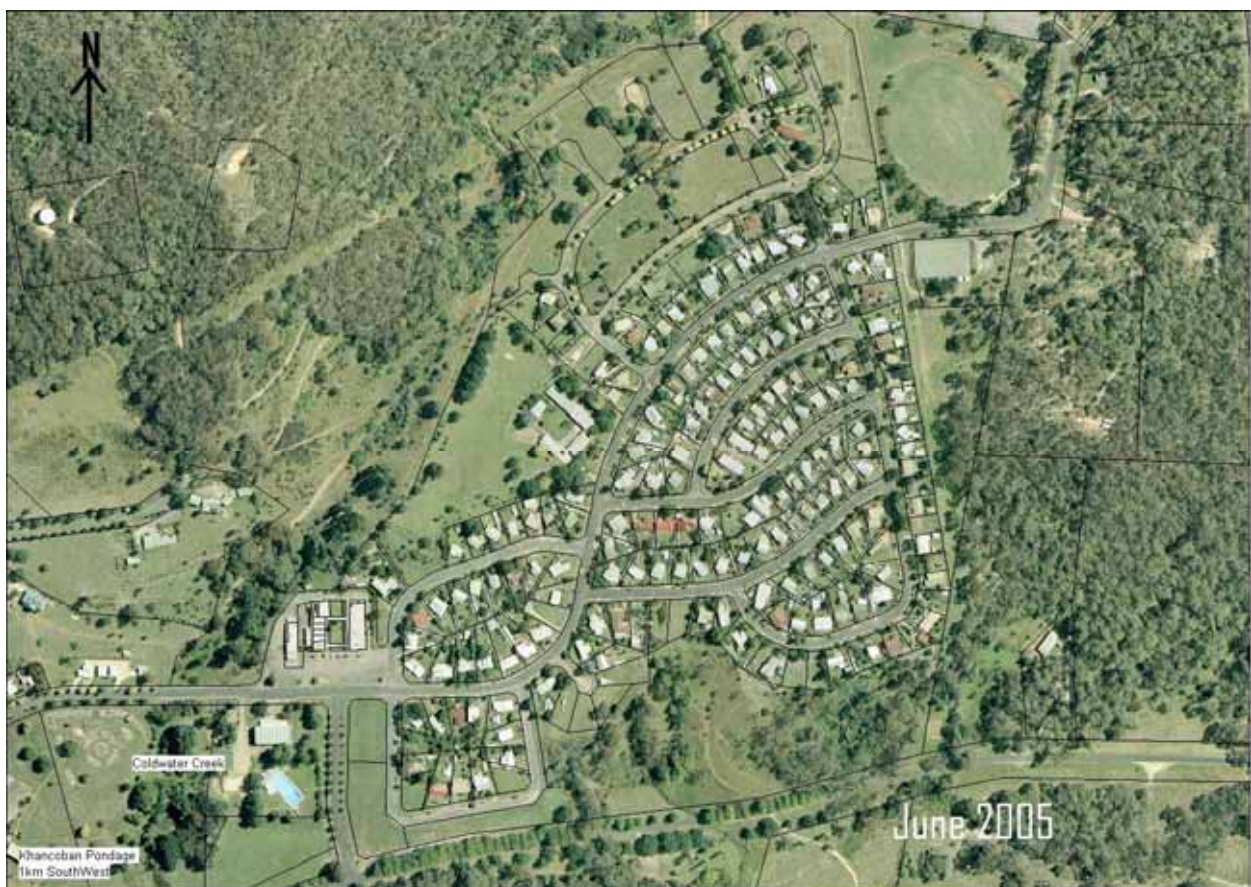
**Figure 2.5: Layout of Khancoban Township**

Khancoban Creek, which is the water supply source for the township, flows from Kosciuszko National Park to Khancoban Pondage, which is part of the Snowy Mountains Scheme. Coldwater Creek flows intermittently through the township.

Khancoban is situated immediately to the west of mountainous terrain. The township has undulating topography and slopes towards Khancoban Pondage (the vertical slope is about 50 m).

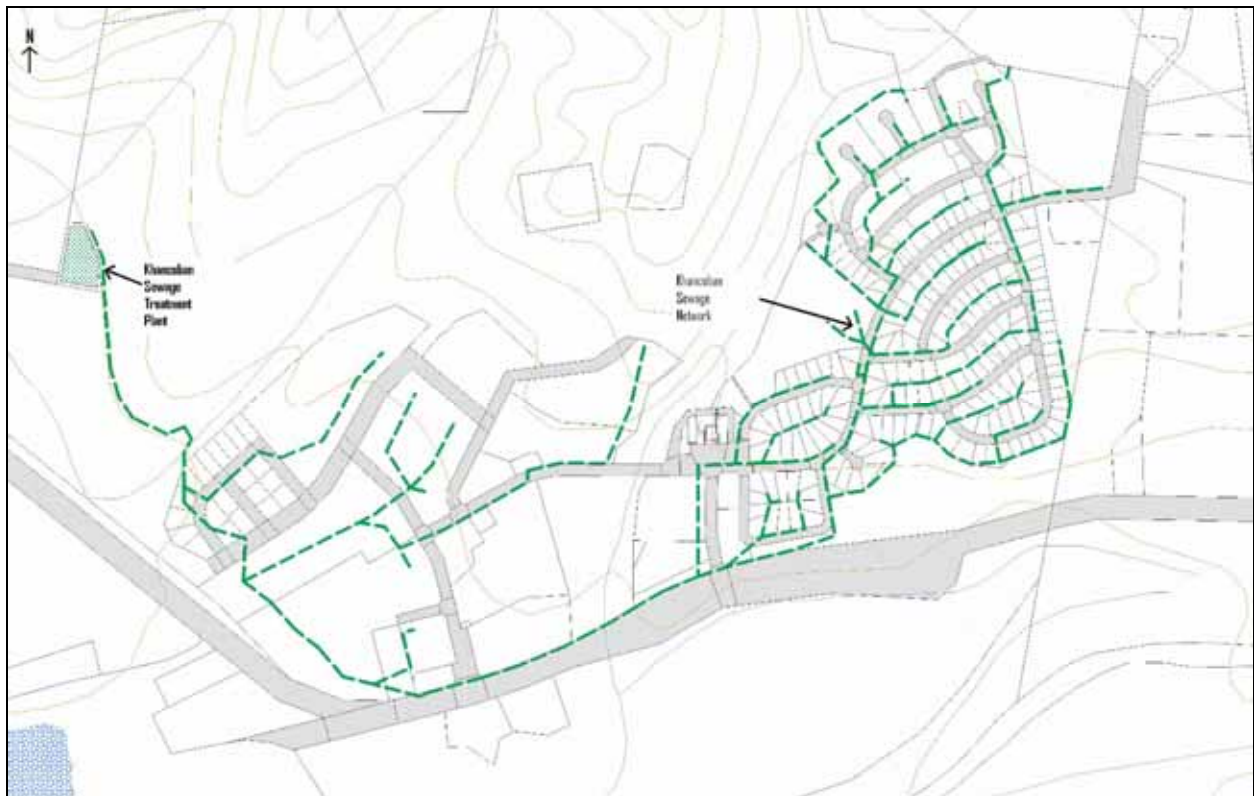
**Figure 3.8: Layout of Sewerage System-Khancoban**

- Approximately 4.85 km of trunk mains of 225 mm (1.65 km total length) and 300 mm (773 m total length) nominal diameters. 86% of the trunk mains are constructed of concrete. All of the 300 mm and about 80% of the 225 mm trunk mains were constructed in 1960 and are nearing the end of their theoretical useful lives.
- Approximately 16.2 km of reticulation sewers of 150 mm nominal diameter. The majority (88%) are concrete pipes constructed in the early 1960s, which are nearing the end of their theoretical useful lives.
- A 2,500 EP Trickling Filter wastewater treatment plant.

The layout of the Khancoban township sewerage system is shown in Figure 3.8.

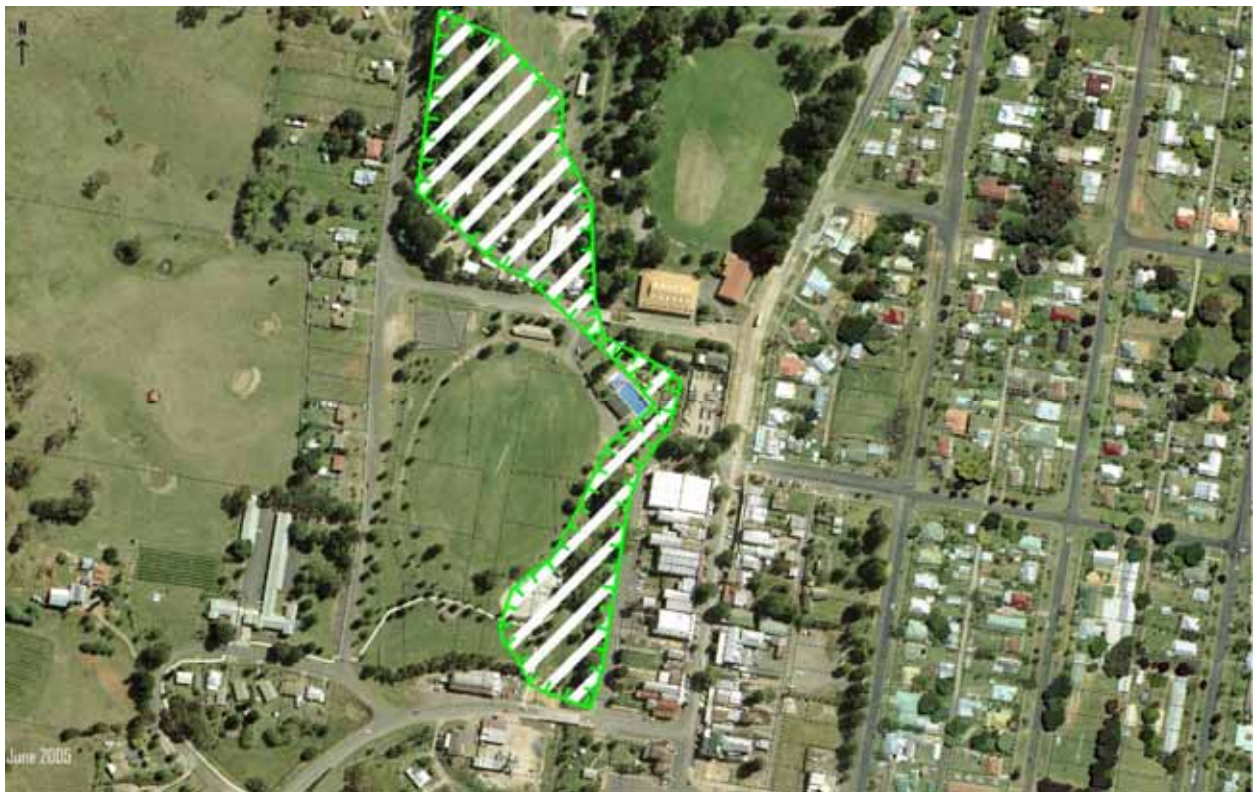
**Figure 3.10: Aerial Photo of Flood Prone Area-Tumbarumba**

The map of Tumbarumba showing the area that can flood (hatched area) is shown in Figure 3.10.

The Caravan Park, Show Ground and creekscape along Tumbarumba Creek are prone to flooding because they are located on the floodplain of Tumbarumba Creek.
